# MARWOOD LTD TEST REPORT

TESTING OF MARWOOD LTD. PRESSURE-TREATED-PINE "STAIR RAIL" WITH ALUMINUM BALUSTERS, TO ASSESS RESISTANCE TO LOADS ON GUARDS AS PRESCRIBED IN THE 2015 NATIONAL BUILDING CODE OF CANADA (NBC) AND 2012 ONTARIO BUILDING CODE (OBC).

104696156TOR-008

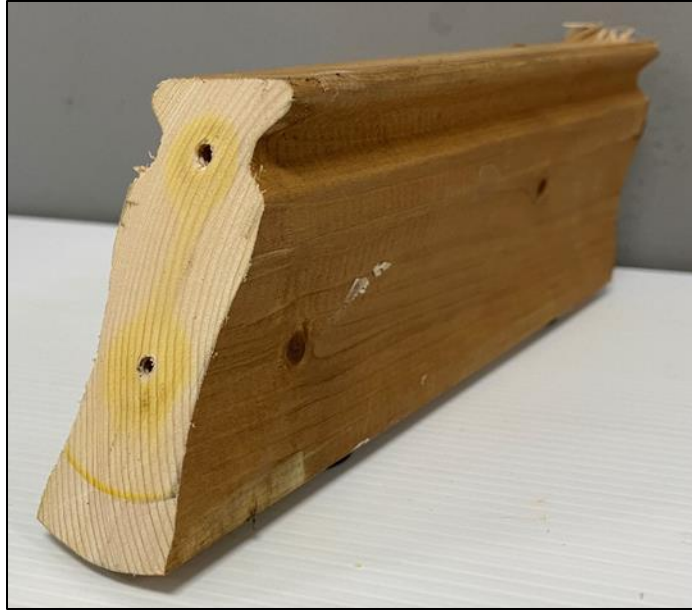
**Photo No. 1**  
Milled Bottom rail

**Top and Bottom Rail:** The milled top and bottom rail were 1725 mm long by 32 mm wide by 79 mm high pressure treated SPF rail installed at a 26° angle. The milled handrail which was attached to the top rail measured 75 mm wide by 30 mm high. A notch measuring 35 mm by 9 mm was routed on the underside of the handrail which was fitted to the top rail. The handrail was glued and fastened to the top rail with four 2-½" finishing nails. The black plastic rail hanger was fastened to the ends of the top and bottom rail using two #8×1-1/2" flat head screws with 17.8 mm dia. x 1.6 mm thick washer. The rail hanger was secured to the pressure-treated pine post with four #9×1-1/2" flat head screws. The post had a 35 x 75 x 4 mm notch which allowed the rail hanger to be mounted flush. The top and bottom rails were spaced 784 mm (31") apart. Testing was conducted simulating the top of the upper rail as 1070 mm from the deck floor.

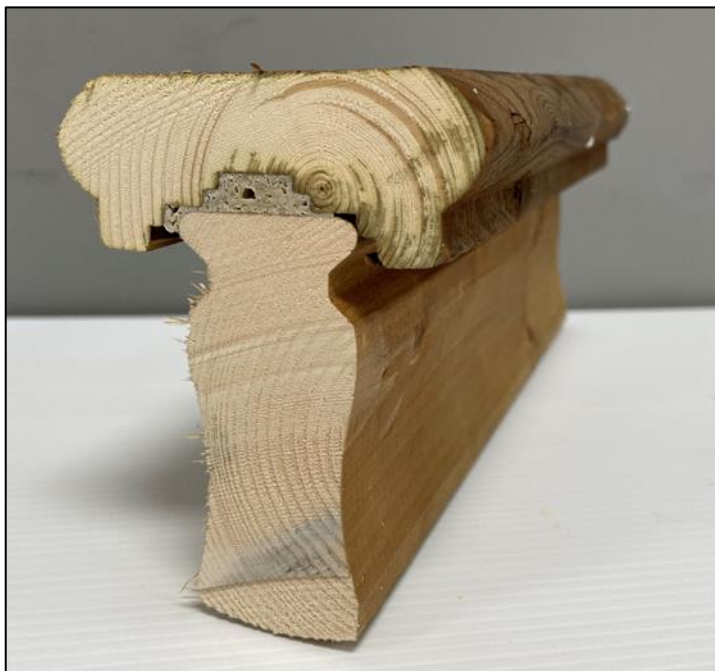
**Photo No. 2**  
Milled Top rail and Handrail
